# 737 GRAPHITE COMPOSITE FLIGHT SPOILER FLIGHT SERVICE EVALUATION

FIRST ANNUAL REPORT  
JULY 1973 THROUGH MARCH 1975

Prepared under contract NAS1-11668 by  
BOEING COMMERCIAL AIRPLANE COMPANY  
P.O. Box 3707  
Seattle, Washington 98124

May 1975

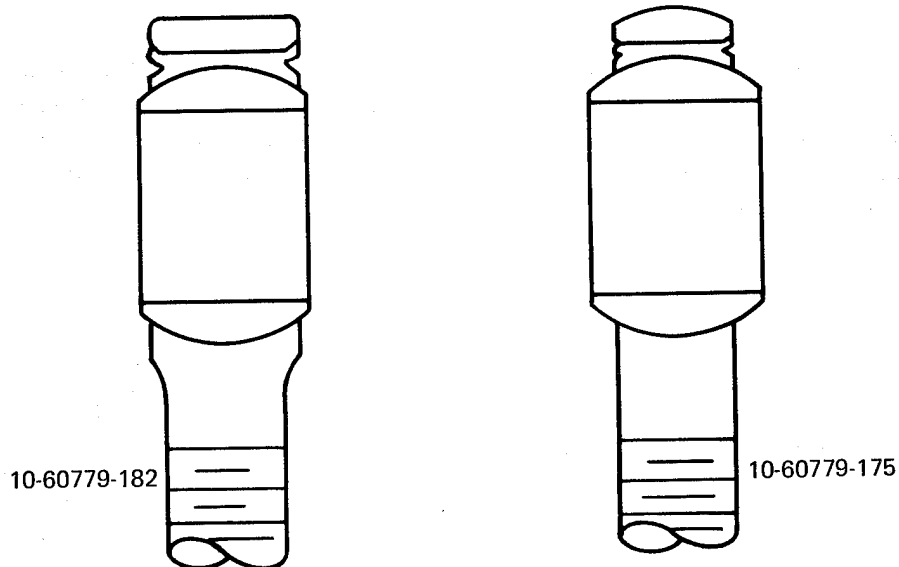
Figure 5.—Actuator Rod End Cross Sections

The most significant problem area has been the occurrence of upper surface skin blisters. This problem has been investigated and determined to be the result of an interference between the actuator rod end and the inner surface of the upper skin, when the rod end is in the "hard-over" position. Since the graphite skin is thicker,  $\approx 0.091$  vs  $0.081$  cm ( $\approx 0.036$  vs  $0.032$  in.), and stiffer than its counterpart on the production aluminum spoiler, the graphite skin cannot accept the forced deflection without suffering an interlaminar shear failure. This type of problem was first noted in October 1973 on an Aloha 737. After the third such incident was reported in July 1974, a fleet survey of Aloha was conducted by the program technical leader. This survey disclosed six additional spoiler blisters not previously reported. Discovery of the rod-end interference problem led to a program-wide survey of all participating airlines to assess the extent of blister damage. This survey (October through November) disclosed three additional blistered spoilers on aircraft of two of the other airlines.

The immediate corrective action available was to replace the offending rod ends with the optional rod end which offers a spherical housing configuration (fig. 5). Replacement rod ends were furnished to Aloha, and rod ends for the remaining airlines were distributed during the January 1975 inspection tour.

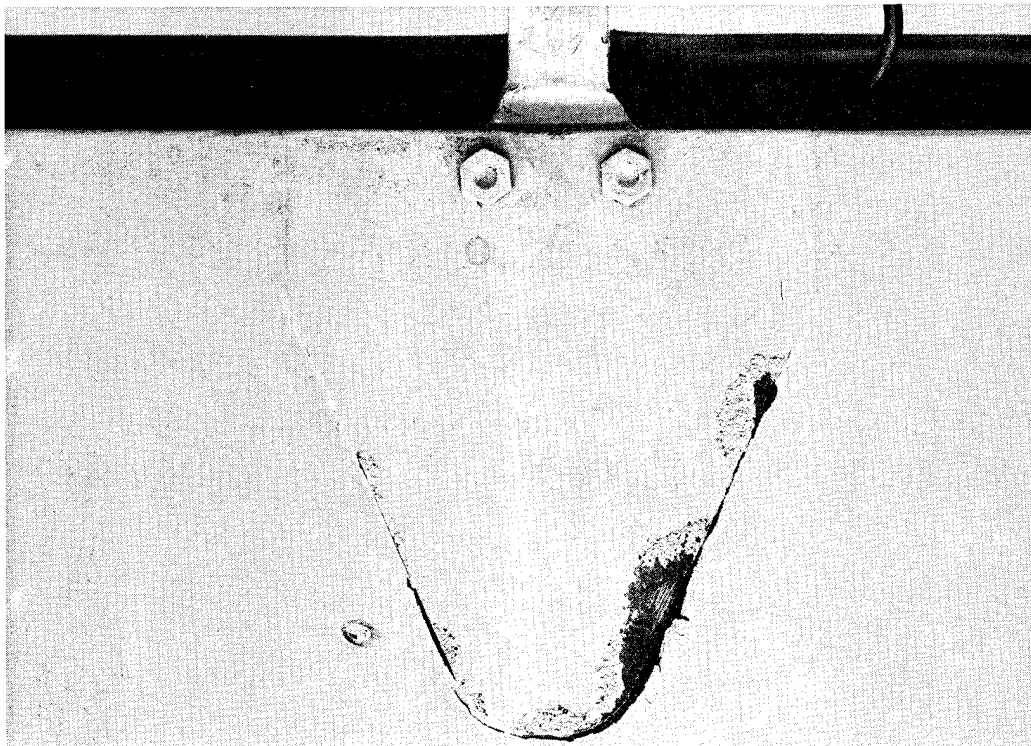
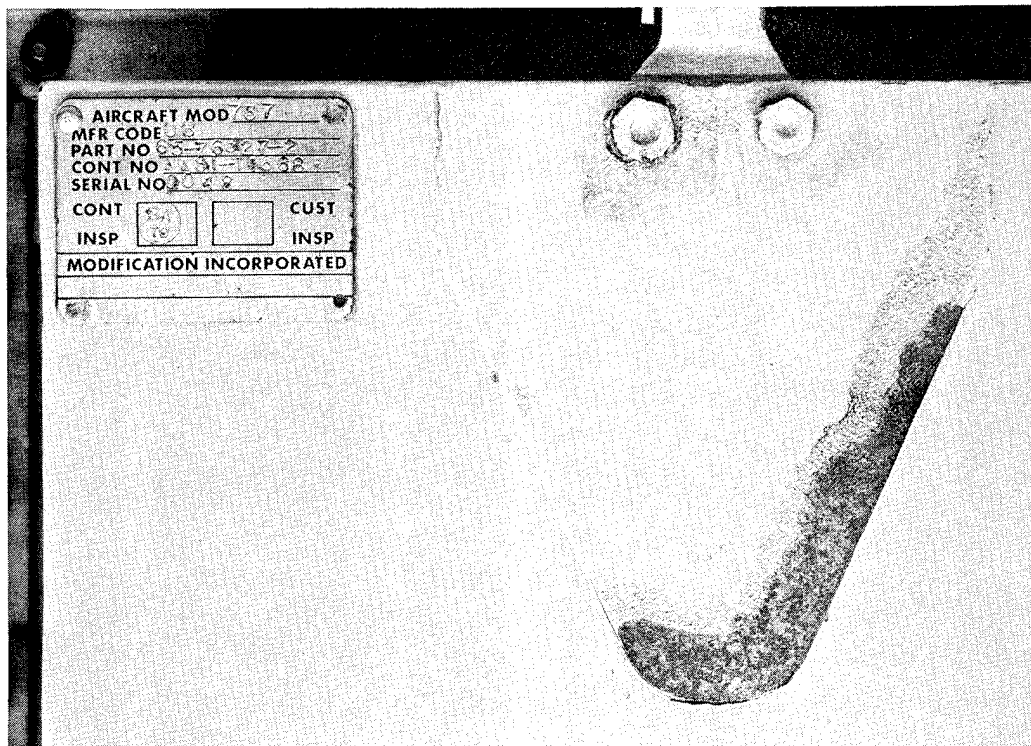
Figure 6.—Corrosion on -23 Doubler

the laminates points out very clearly that extreme caution must be exercised to avoid undesired forced displacements of the laminates. No evidence of corrosion or deterioration of the skin laminates has been observed. One case of corrosion of the aluminum bearing doublers on the spoiler lower skin was observed (spoiler S/N 0048, fig. 6). Investigation of this condition is continuing.

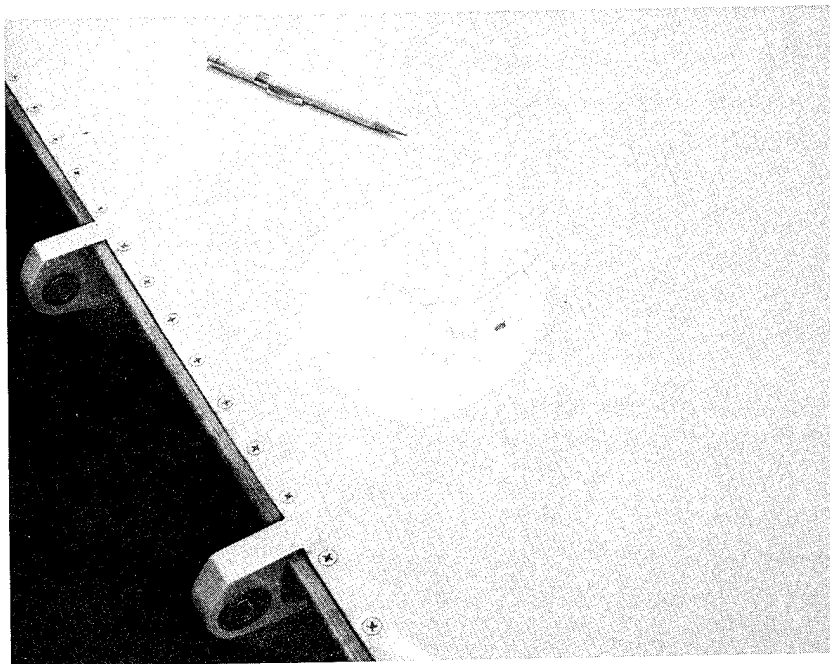
*Figure 7.--Upper Surface Repair Delamination on S/N 0014*

Five spoilers were selected at random for removal following the first year of service. Visual inspection of these units showed no detectable defects and only the oil and dirt associated with trailing edge components, except for spoilers S/N 0014 and 0104. Spoiler S/N 0014 showed evidence of delamination of a repair on the upper surface skin above the center hinge fitting (fig. 7). Spoiler S/N 0104 showed an upper surface skin blister, approximately 3 cm (1.2 in.) in diameter, above the center hinge fitting (CHF), which was not repaired prior to its destruction in static test.

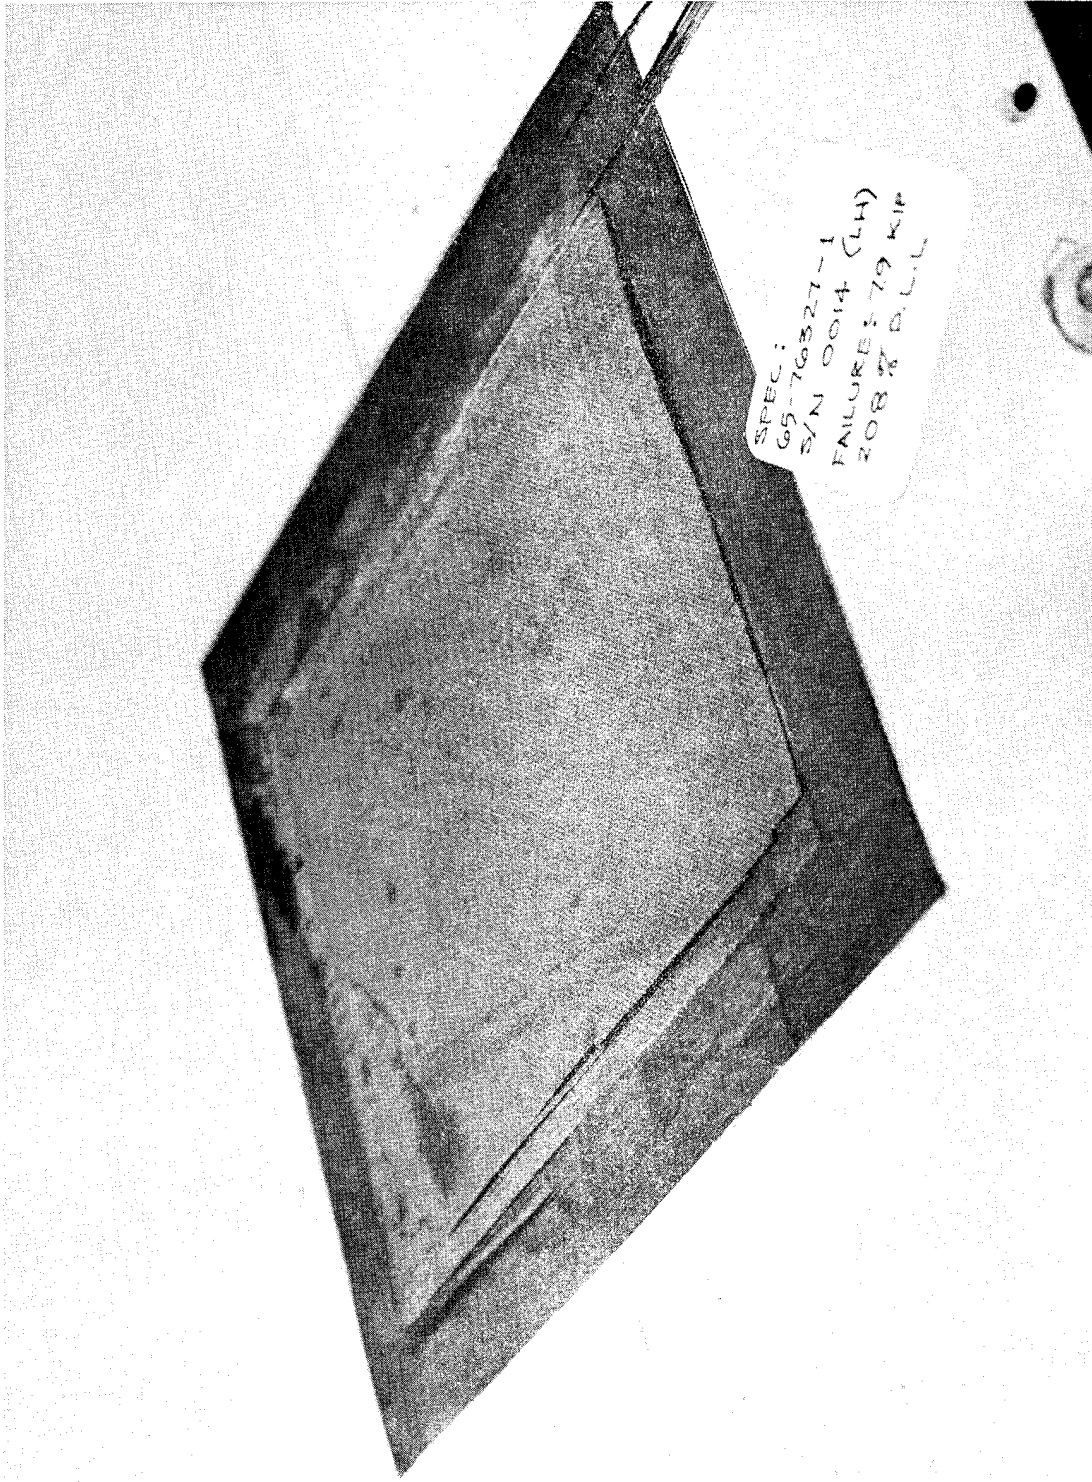
1. Initial failure of S/N 0014 was brought about by the combination of shearing of the -11 aluminum doubler above the CHF and failure of the repair patch on the upper skin above the CHF. The failure load achieved was attained despite a "resin only" joint around the edges of the repair. Repair procedures have been modified to include EA 9628 adhesive in the repair lap joints. Although the failure occurred in the skin repair area, the percentage loss in failure load was essentially no greater than for the other two test specimens. Failure of the comparable certification test spoiler (S/N 0002) was attributable to lower surface skin buckling near the CHF due to deflection of the CHF.

Figure 11.—Failure of S/N 0014 Through Repair

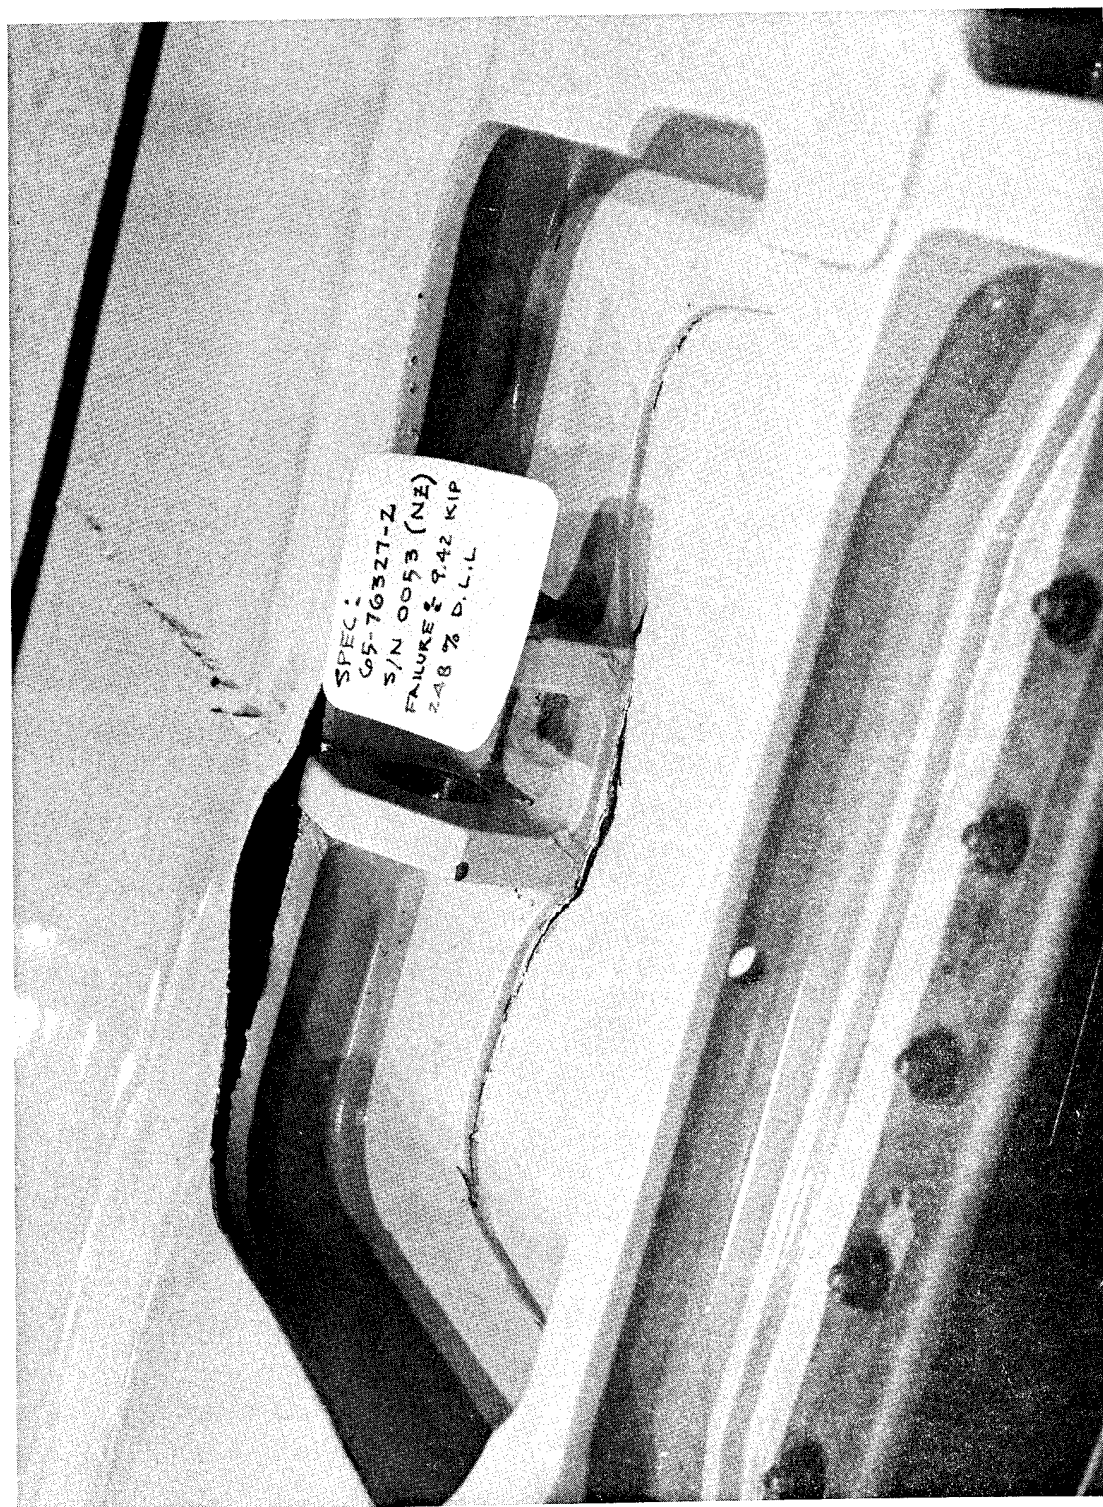
2. Failure mode of the T300/5209 spoiler (S/N 0053) has been assessed as a primary lower skin buckling immediately adjacent to the CHF. An additional failure of the -11 aluminum doubler under the upper skin precipitated the upper skin tension failure. Both failures were influenced by deflection of the CHF. Failure of the comparable certification test spoiler (S/N 0041) was attributed to upper surface skin tension failure precipitated by yielding and failure of the CHF.

Figure 12.—Failure of S/N 0053 Above and Below Center Hinge Fitting

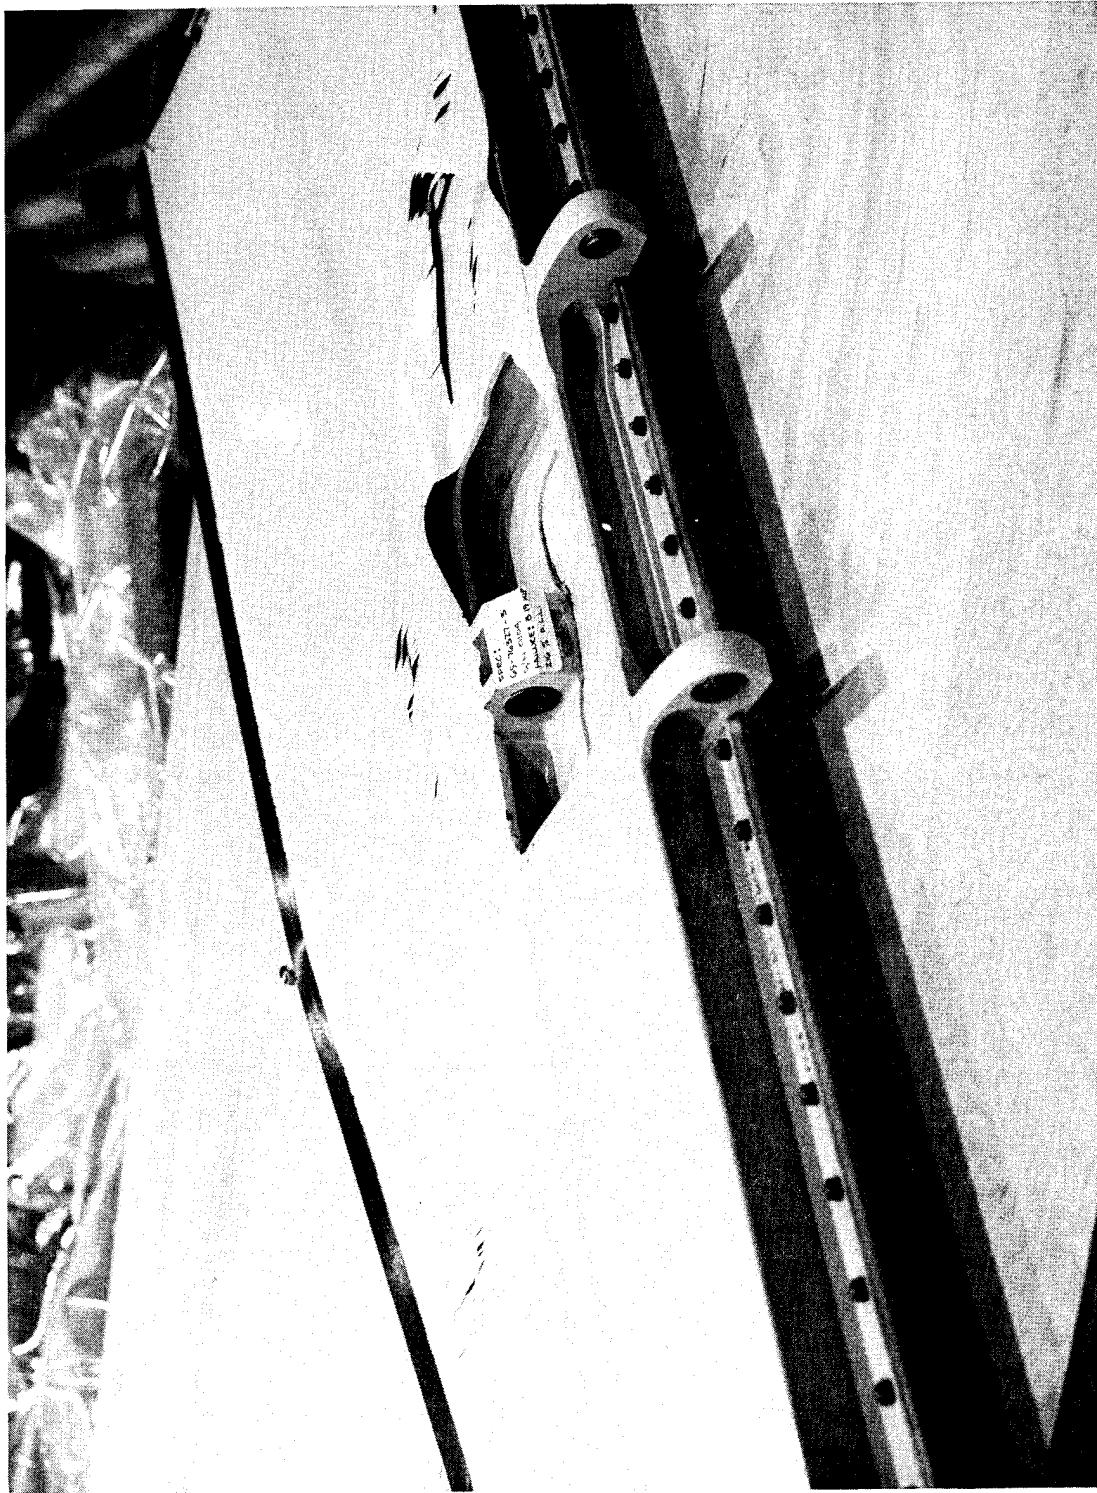
3. Failure mode of the AS/3501 spoiler (S/N 0104) was indicative of a shear failure in the bondline between the honeycomb core and the CHF, with secondary shear failure in the honeycomb core along the spoiler centerline. The comparable certification test spoiler (S/N 0081) failed in buckling of the lower skin near the CHF, with a resulting honeycomb core shear failure along the spoiler centerline.

*Figure 13. —Failure of S/N 0104 Adjacent to Center Hinge Fitting .*

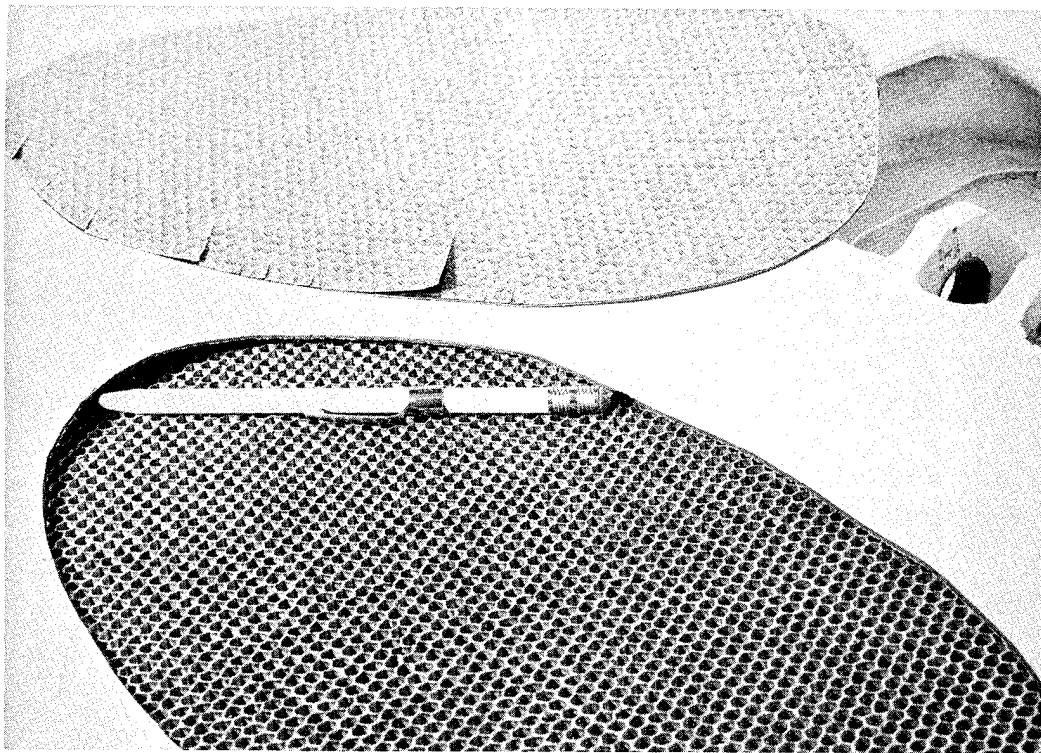
In one instance (S/N 0024), the spoiler, with the upper skin repaired, was not placed in the bonding assembly tool. Instead, a partial bag was prepared covering the repair only. Following autoclave cure and bag removal, a large oval-shaped void, approximately 20 x 30 cm (7.8 x 11.7 in.), was visually noted in the central portion of the lower skin.

The color scan which followed the repair confirmed the void. To visually assess the problem, an oval section of skin was removed (fig. 14). Further examination disclosed that those areas adjacent (in the spanwise direction) to the initial void were also voided or weakly attached. Progressive removal of the entire lower skin was successfully accomplished (fig. 15). An entire new lower skin was successfully bonded to the spoiler frame, with the subsequent NDT inspection showing a void-free bondline. Following the repainting and reinstallation of details, the spoiler was returned to service.

*Figure 14.—Skin Removed From S/N 0024*

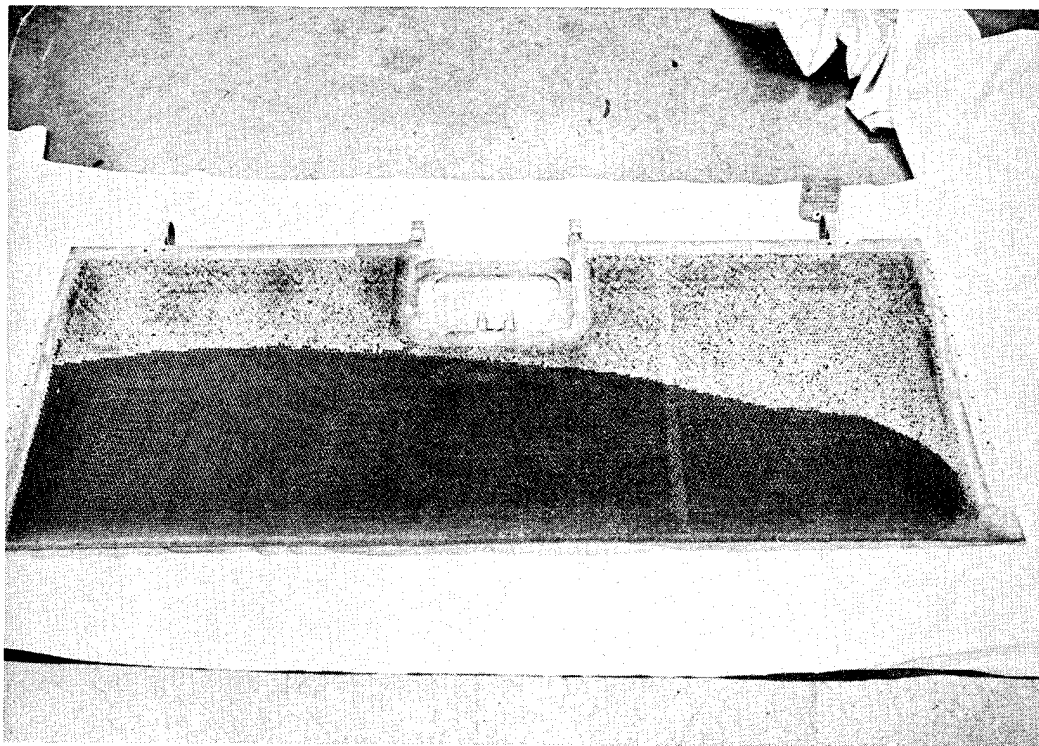
*Figure 15.—Lower Skin Completely Removed From S/N 0024*

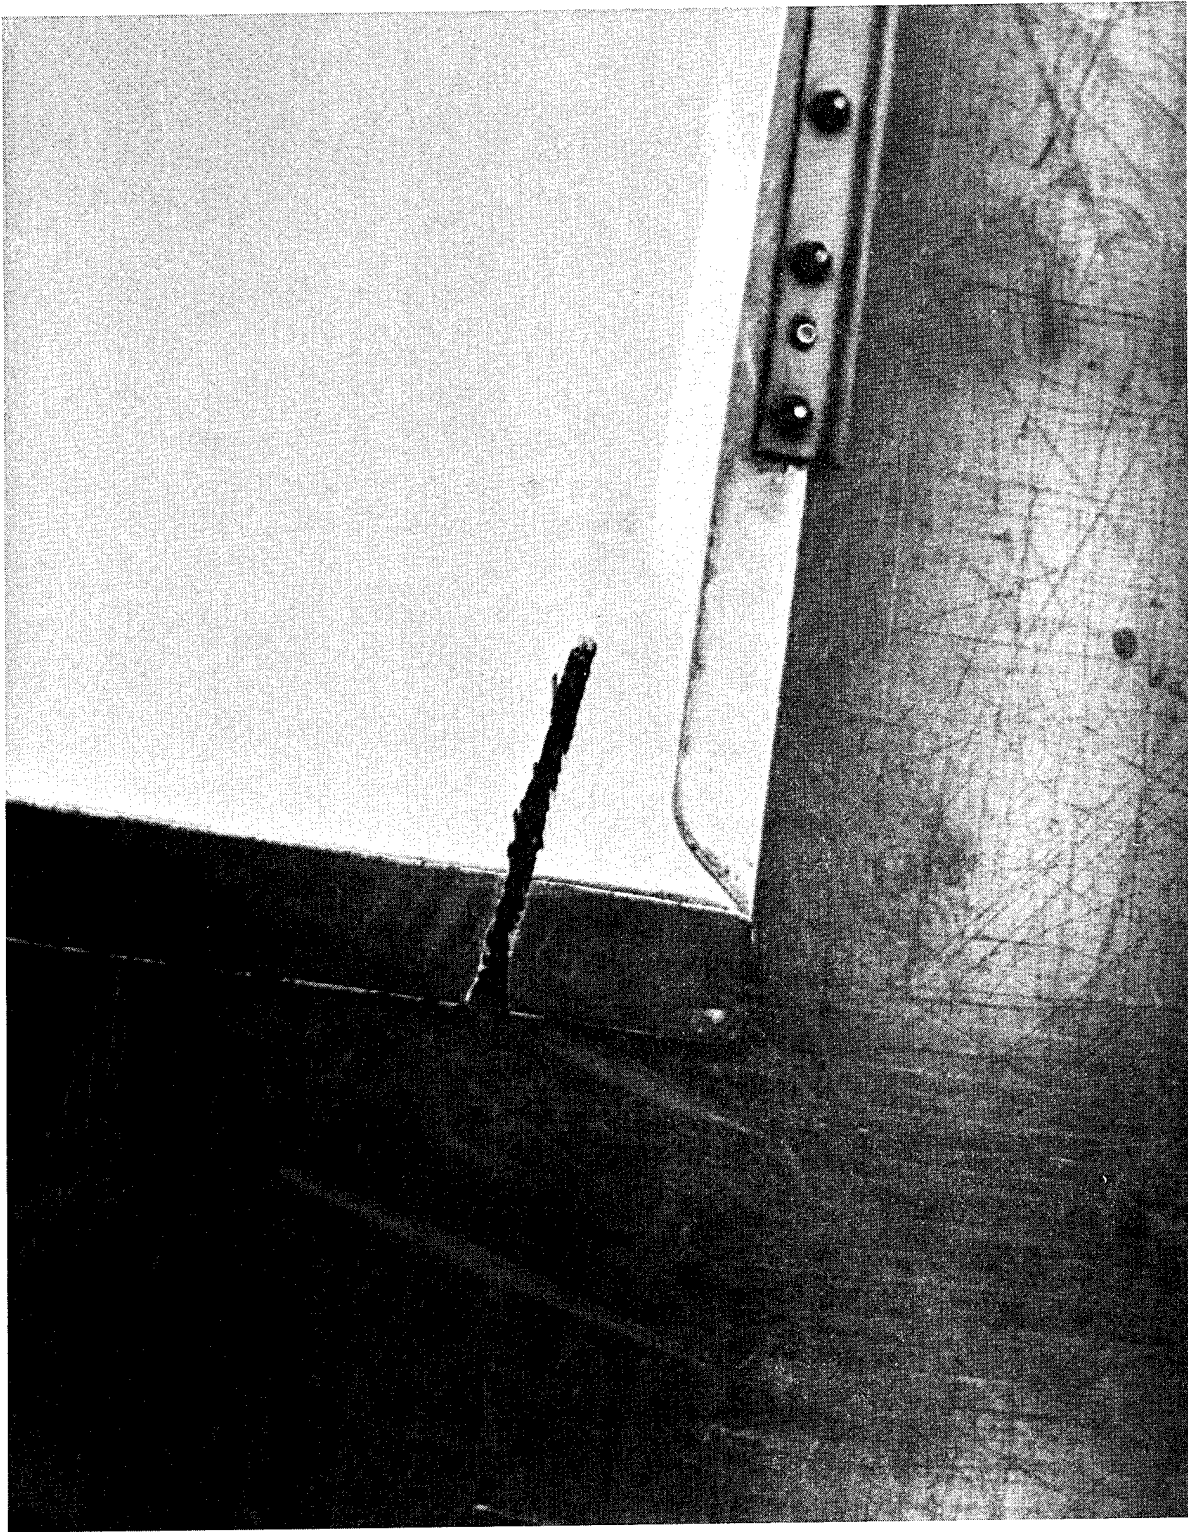
In June 1974, New Zealand National Airways reported that spoiler S/N 0089 had been inadvertently damaged by a control cable during aircraft overhaul. The nature of the damage was a slot cut through the spoiler thickness for a length of approximately 6.6 cm (2.6 in.) from the trailing edge. This damage has been repaired by Boeing, and the spoiler has been returned to National Airways and reinstalled.

*Figure 16.—Damaged Trailing Edge of S/N 0089*
